# AO<sub>3</sub> Solutions

**Installed 5 Stainless Steel Lagoon Masters and SewperRx Microbial Blend**

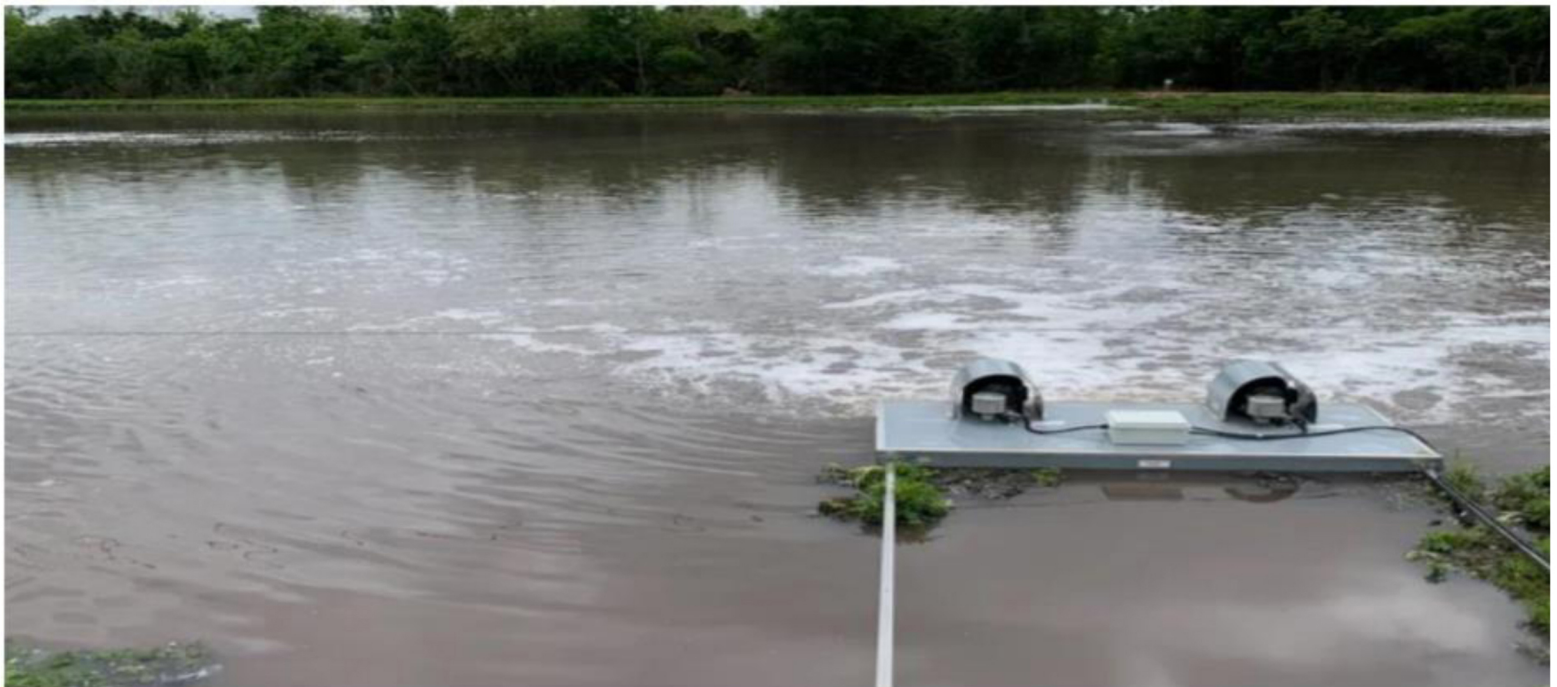
This photo was taken 5 days after AO3 Solutions installed the (5) Lagoon Masters. The odor is eliminated, and the color of the water has turned from black to brown, the indication of an aerobic ecosystem. The grease burls are broken up and being consumed by the bacteria (SewperRx).

With the installation of the Lagoon Masters and introduction of SewperRx Microbes this lagoon has transformed into working EQ lagoon.
